## NOTES ON THE LYNTON & BARNSTAPLE COACHES

These notes have been compiled to go with the drawing set produced by R Wilkinson and are intended as an aid to the modeller. There are many books and a few videos about the Lynton & Barnstaple (see References), which were used to compile these notes.

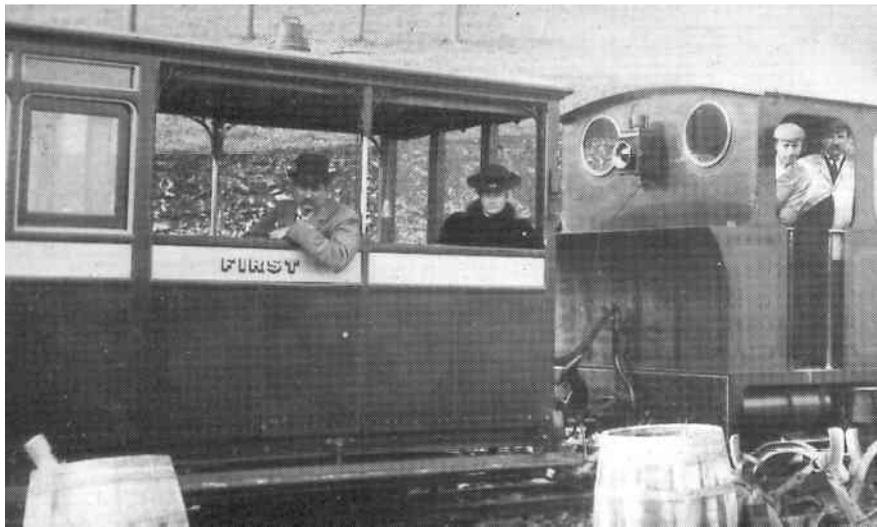
In the first Class Saloon, there were 3 transverse seats and 6 longitudinal seats (three per side. Leigh states that 'the observation part contained a central outward facing bench seat for six passengers'<sup>3P83</sup> (If this was so, the seat would have blocked the sliding door). The photographs below suggest that there were three seats each side facing inwards, or was this done when the open sides were glazed? The open part had canvas weather blinds, it would not have been a good idea to have expensive cloth seats exposed to the elements, therefore Leigh could be correct with his assumption. But, what are the two people sitting on in this photograph of the first train to reach Lynton?

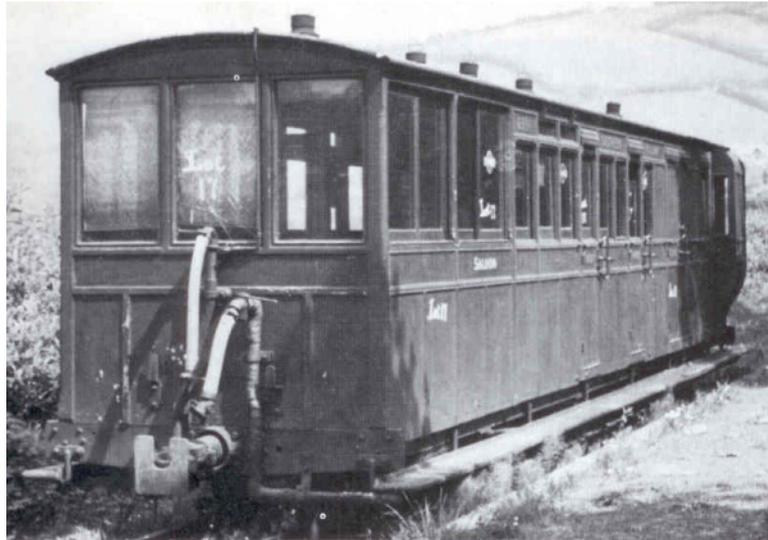
Coach No.1 in SR Livery Left at Snapper Halt after closure<sup>2</sup>

According to Leigh, No.1 was sold privately at closure then later scrapped.

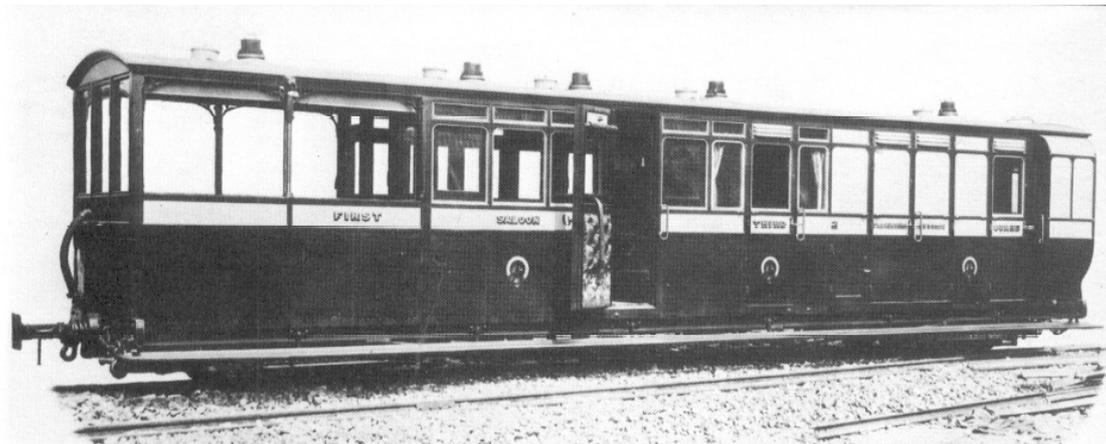
Coach No.2 in Original Livery<sup>1,3P82</sup>

No.2 was sold to a rectory near Coplestone for a summerhouse at closure. In 1982 it was moved to the York National Railway Museum<sup>1V</sup>, it is still un-restored.

There are two different photographs of Coach 2 when new. Each of the photographs shows the coach pointing in a different direction. It seems that the coach was delivered with the observation end viewing Lynton, but the coach was soon turned around so that the observation end faced Barnstaple. All, except the few very early photographs (on completion of the railway construction) show the observation end of coaches 1, 2 & 17 (glazed ends) facing Barnstaple. Therefore the drawings of these coaches is technically 'the wrong way around'.

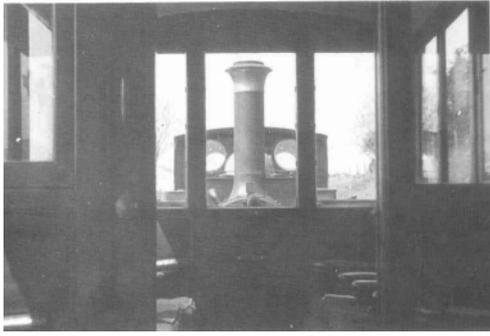
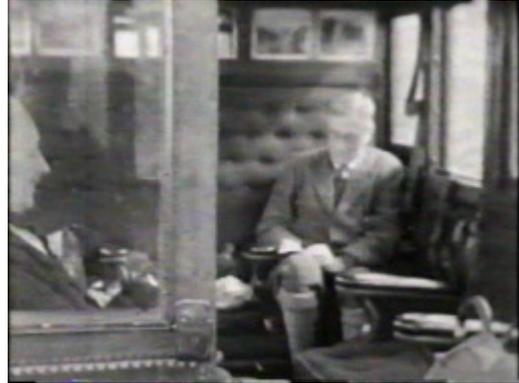
Interior First Class Observation<sup>1</sup>

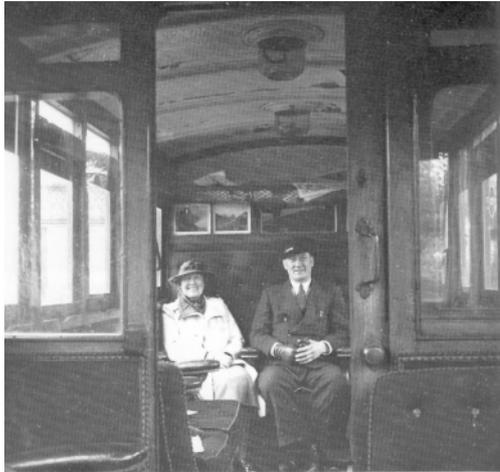
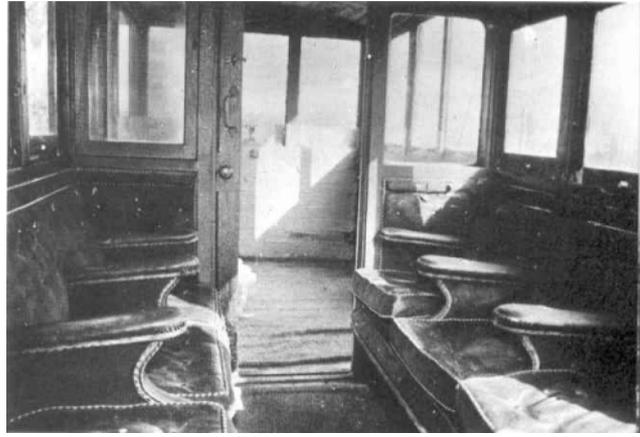
Interior First Class Observation No.2 (6992) at Clannaborough<sup>3P87</sup>

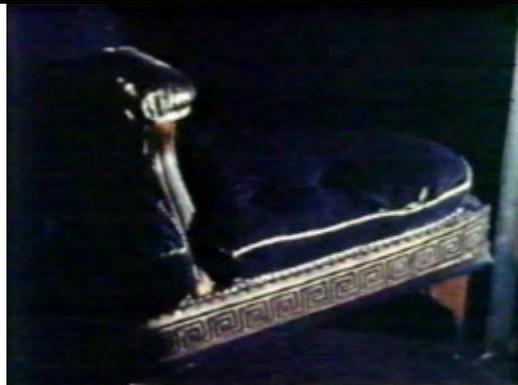
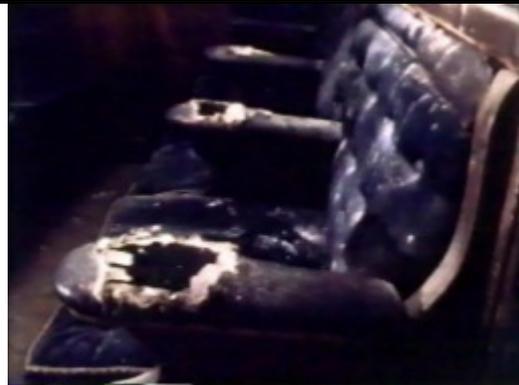
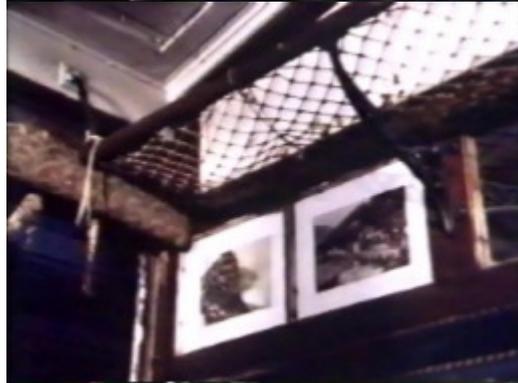
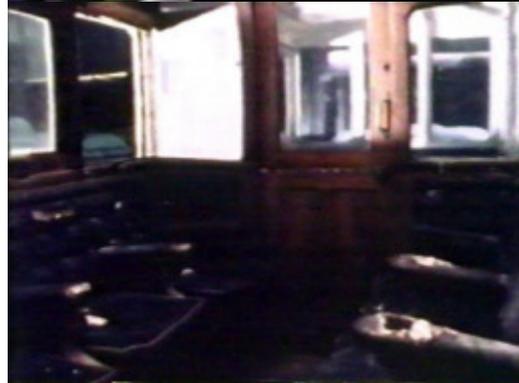
Coach 2 Interior – York Railway Museum<sup>2V</sup>

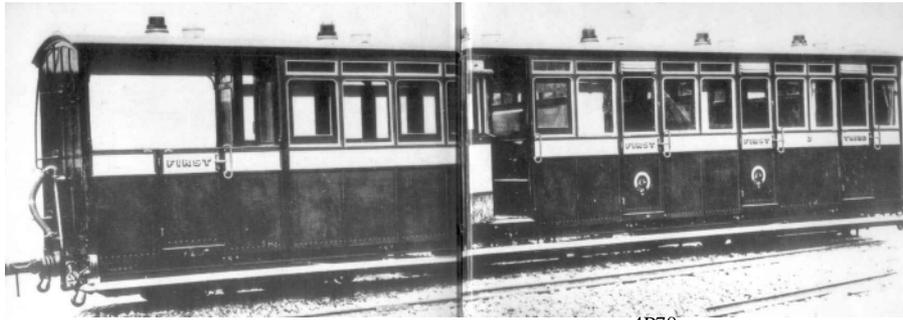
Coach No.3 in Original Livery<sup>4P78</sup>

Again we have the discussion about the seating arrangement in the First Class 'Saloon part of these two coaches. According to Leigh: 'the first salon had three seats across and four seats each side facing inwards'<sup>3P85</sup>. The open part had a centre half door with a solid end, this could not have been popular as observation vehicles and the sides were rebuilt and glazed to provide conventional first class compartments'.

Leigh also shows in his drawings, that was a sliding door connecting the salon part to the observation part, also showing two single seats either side of the door. I think that it can also be assumed that the seat against the end panel was all the way across. But again, how were they upholstered?

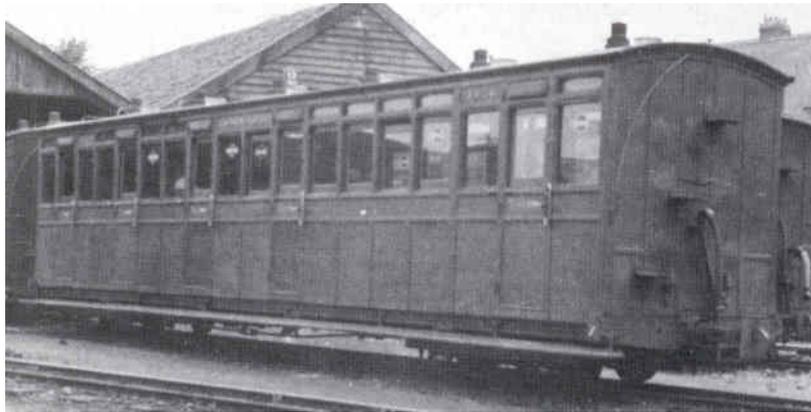
Coach No.4 in SR Livery Converted to all Third<sup>2</sup>

Leigh then goes on to state that: 'In 1929 the first class upholstery was replaced with wooden seats and the vehicles were down graded to 46 seat Thirds.

Catchpole states that Coaches 3& 4 were altered from Composite to Third May 1925<sup>1</sup>

Another look at the photograph of coach 4 in SR days, a heating pipe is not evident, but there is one on the coach in the background.

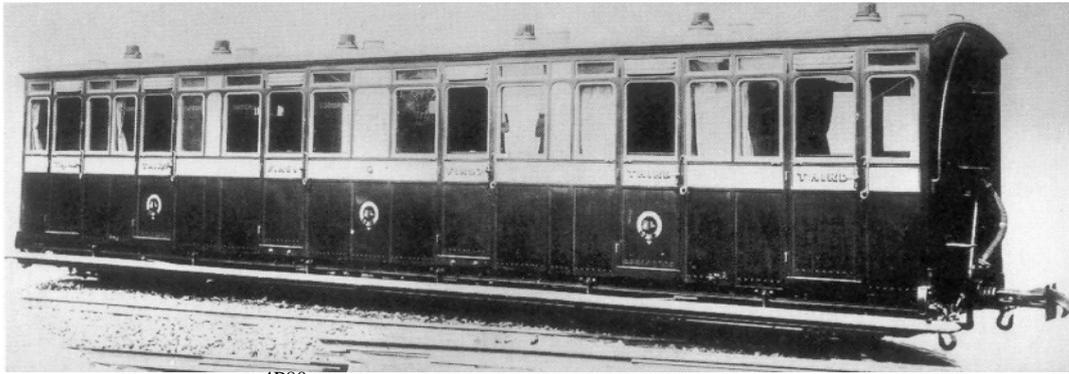
Coach 6 in 1<sup>st</sup> livery<sup>4P80</sup>

Straightforward composite coaches with all compartments separated by panels. Leigh goes on to state that ‘the first class partitions were solid’<sup>3P85</sup> this implies (but not stated) that the partitions between the third class compartments were glazed.

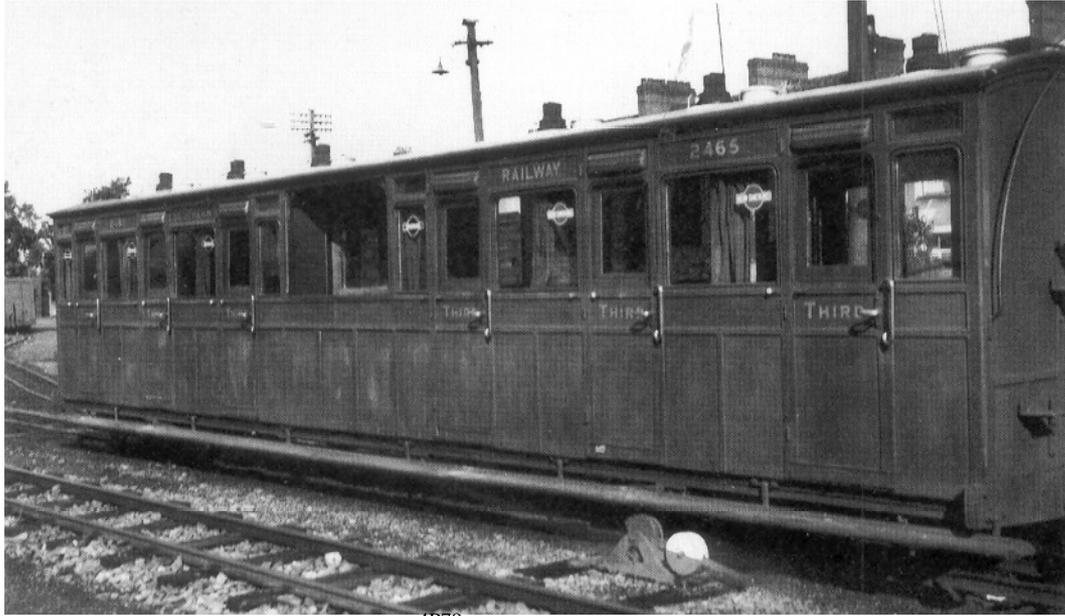
Coach 7 (SR6466) in SR Livery<sup>4P79</sup>

These coaches did not have compartment partitions. The centre observation part is reported to have four seats (one in each corner). The access door was narrow and offset, so that there was one seat on one side and a double seat on the other side of the door inside the vehicle.

Throughout the life of the railway, these coaches do not appear to have ever been altered and, unlike the other observation coaches, the observation part was never glazed in although the weatherproof blinds were removed.

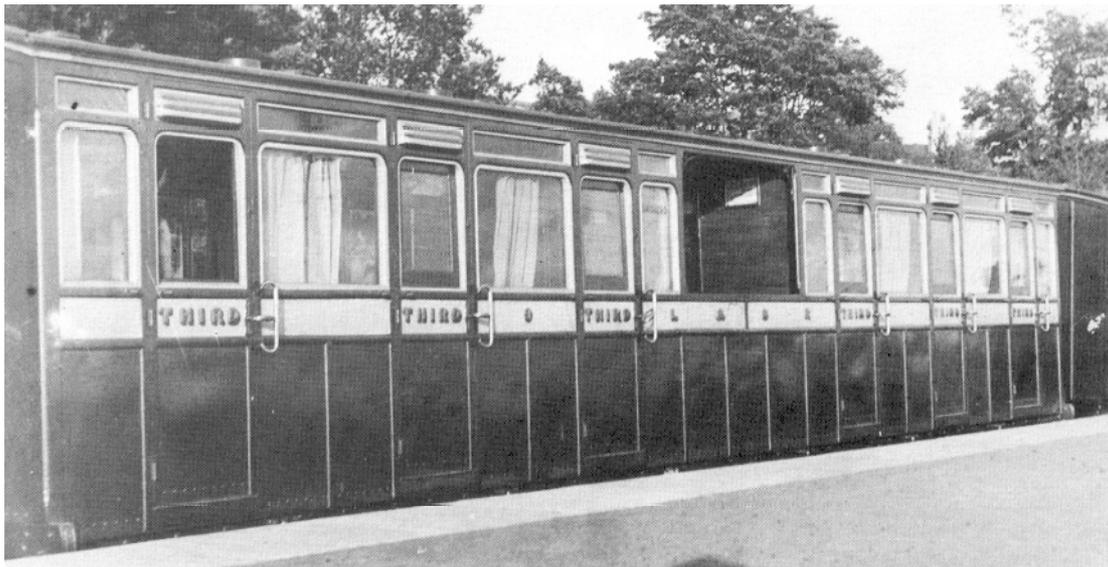
Coach No.9 in Second Livery<sup>1,3</sup>

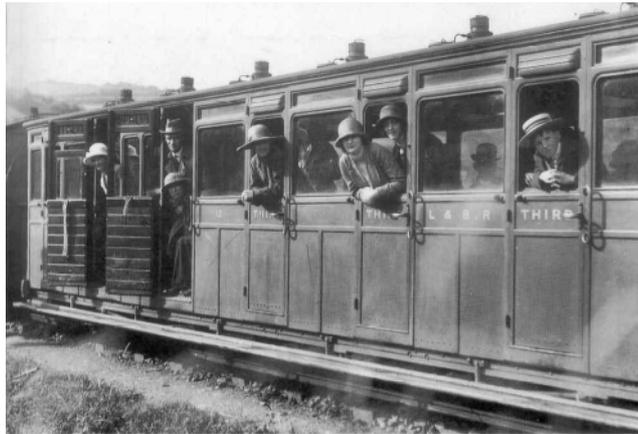
Coach 13 in 3<sup>rd</sup> Livery <sup>4P29</sup>

Leigh: 'Two compartments at the end were separated by a fixed partition, the remainder being provided with sliding partitions which dropped down between the seats when not required. Two, Nos 2471 & 2 were steam-heated by the SR'. <sup>3P85</sup>

The fixed partition would have been to separate the two smoking compartments from the non-smoking compartments.

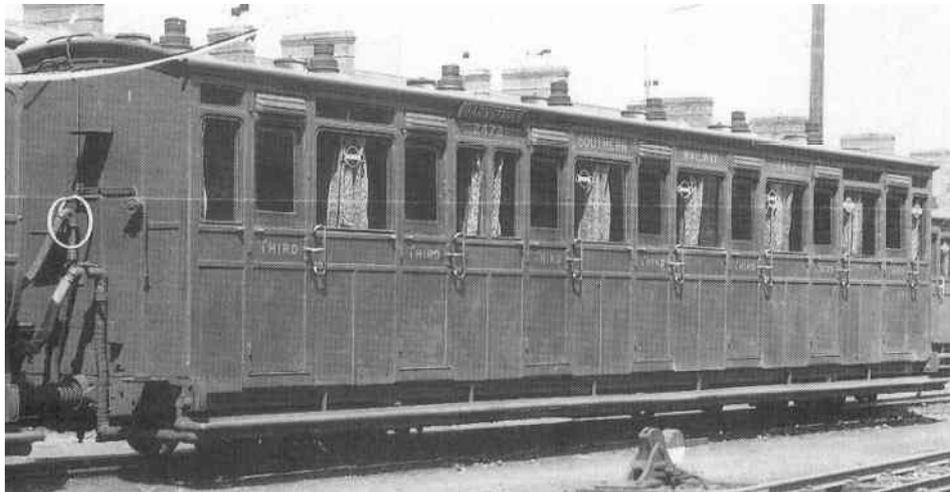
Coach No.14 in SR Livery<sup>1</sup>

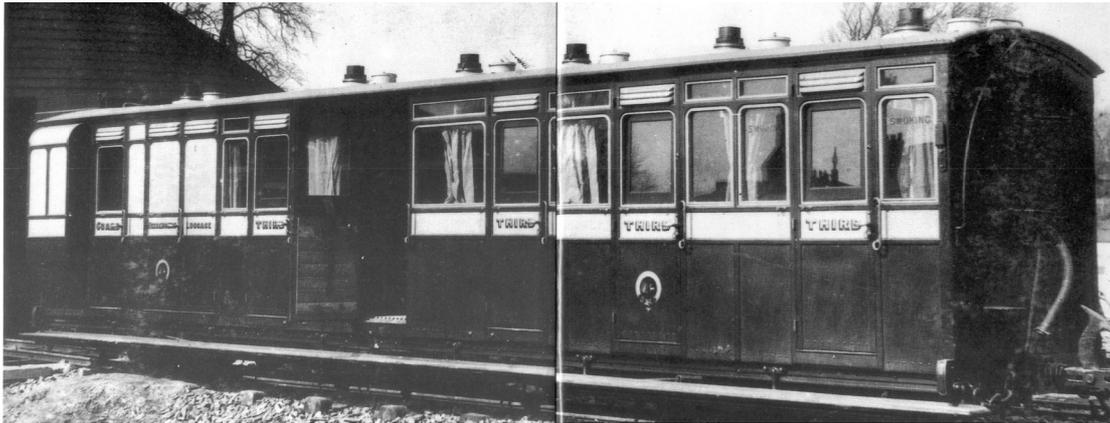
One of the two 'Conventional 3<sup>rd</sup> Brakes' in 1<sup>st</sup> livery<sup>4P80</sup>

The Smoking compartment was separated by a fixed partition, the remaining compartments being separated by moveable partitions as coaches 11 to 14. Coach 16 remained unaltered but Coach 15 was altered to a composite after only a few years service.<sup>3</sup>

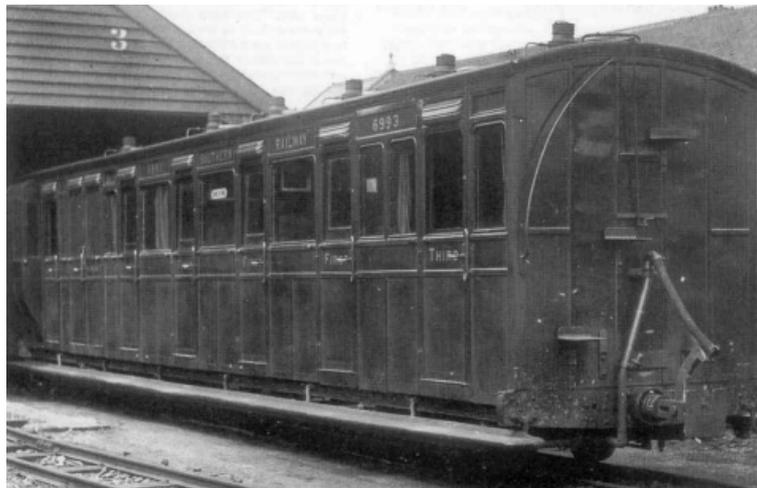
Coach No.15 in SR Livery<sup>4P81</sup>

Coach No.15 in SR Livery Left near Snapper Halt after closure<sup>2</sup>  
Compare the 'direction of coach 15, (the coupling hook) in the above two pictures.

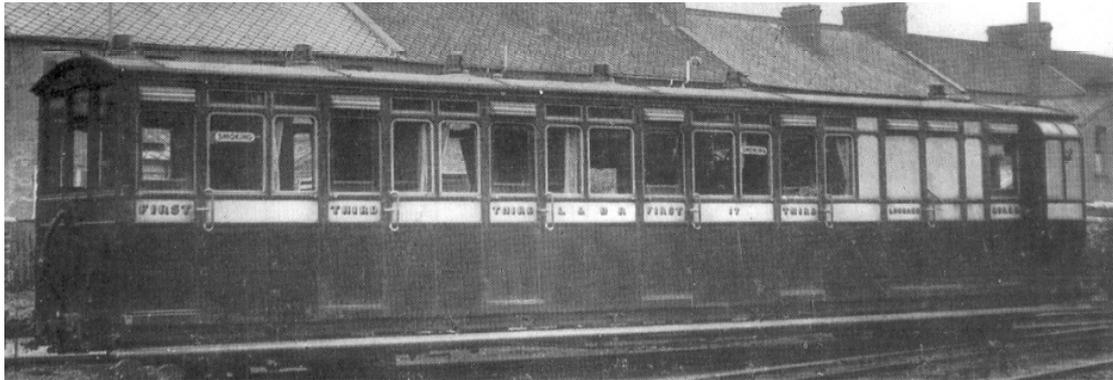
Coach No.17 in L&BR Livery 2<sup>1,4</sup>

Coach 17 was the odd coach being 11½” longer than the first 16 coaches and built by Shapland and Peter (or Petter depending upon which book you are reading) of Barnstaple. Leigh states that the third class compartments were slightly larger and the third class compartments were slightly smaller than the original coaches. Note the variation in ‘SMOKING’ sign.

When delivered the word 'SMOKING' printed (apparently in red) on the window either side of the door to a smoking compartment. The exception seems to be coach 17, which was different (see photo).

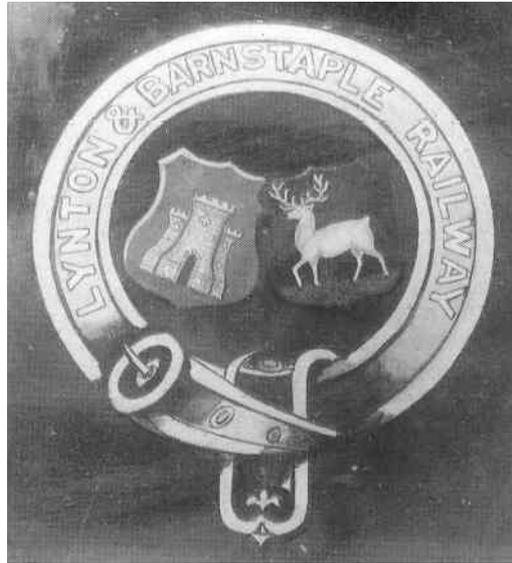
1. The original Livery was Lake lower panels and White upper panels, a style similar to that used on the LNWR. The lettering on the waist panels was in gilt block letters, shaded black with the company crest in the centre of the door panel. The roofs were White with Black lamp holders, running gear and underframes.<sup>1P26</sup>

2. Same as the first livery except that the company crest was no longer on the door panel and the letters L & B R were placed on the waistband of the coach.
3. Leigh: 'Shortly after the SR takeover, some vehicles were painted in plain brown'.<sup>3P83</sup>
4. The fourth livery was 'Standard Southern Railway Green'. Some upper window lights were plated over to accommodate the Southern Railway lettering.

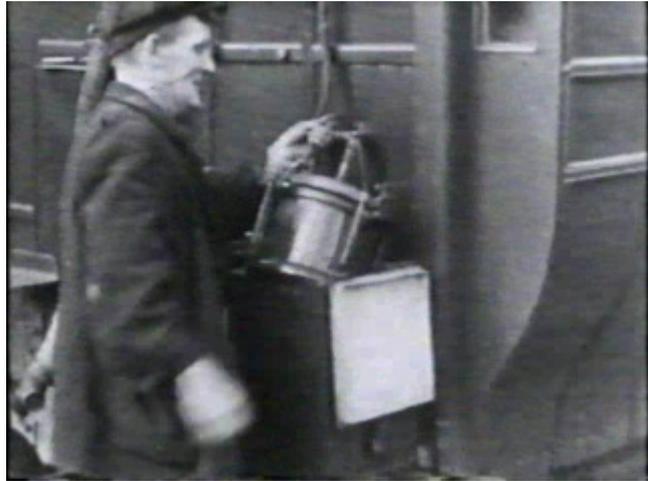
Leigh: oil lamps, which fitted through a hole in the roof, provided Coach lighting a plug being carried in an adjacent holder for use when the lamp was removed. Each compartment or seating bay had one lamp. The change to acetylene lighting was commenced within the first few years of operation, and although some vehicles were not initially fitted with acetylene generators, photographs suggest that all eventually received them.<sup>3P82</sup>

The Author of this document would dispute the above statement, in that 'photographic evidence' does not necessarily suggest this. Further more, Leigh goes on to suggest that not all of the coaches were fitted with a generator and that the generator on the end of the coach actually supplied the next coach by means of a connecting pipe. The Author is not entirely in agreement with this statement either.

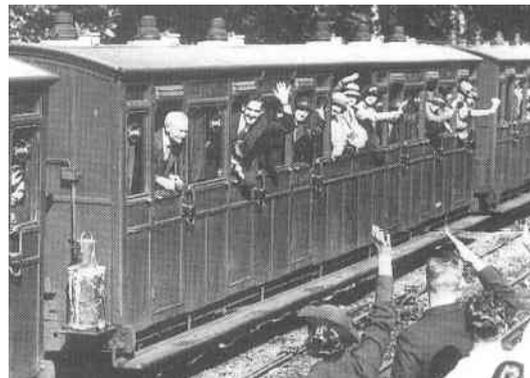
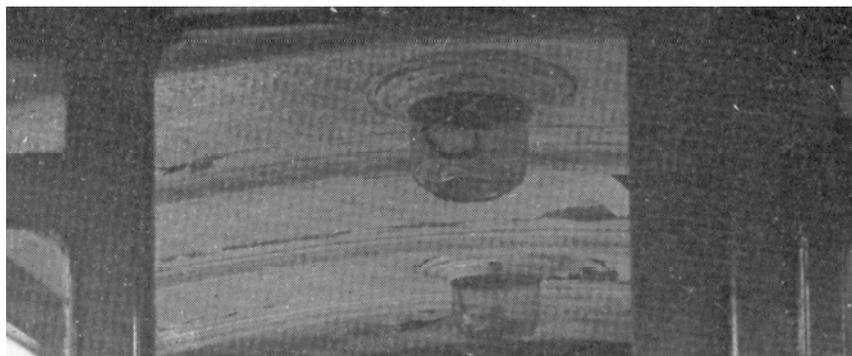
View of the 'Last Train' clearly showing a centre observation coach with an acetylene container in the foreground and a 'box' on the carriage in front.

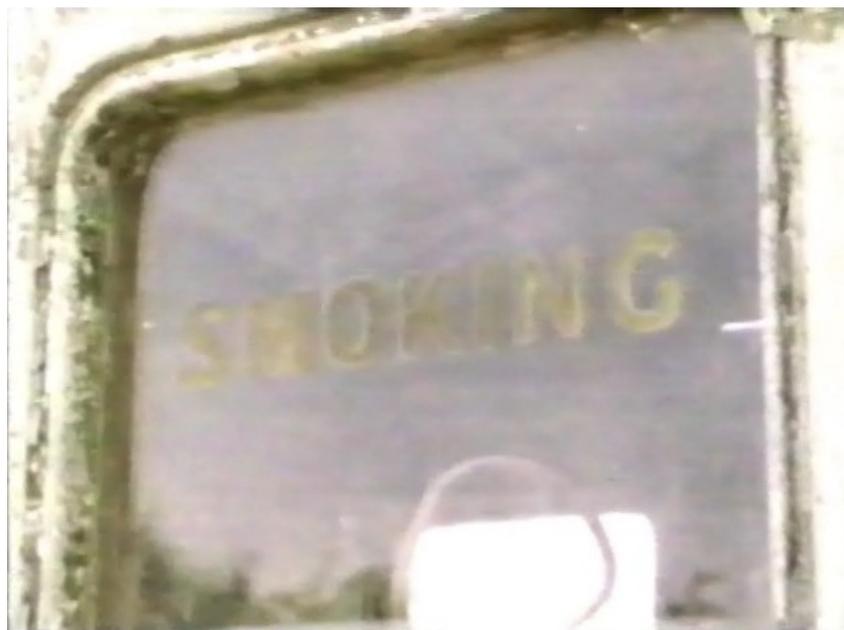
The SR placed round & rectangular 'NON SMOKING' signs on one of the adjacent windows to every door plus additional ones on the saloon windows.

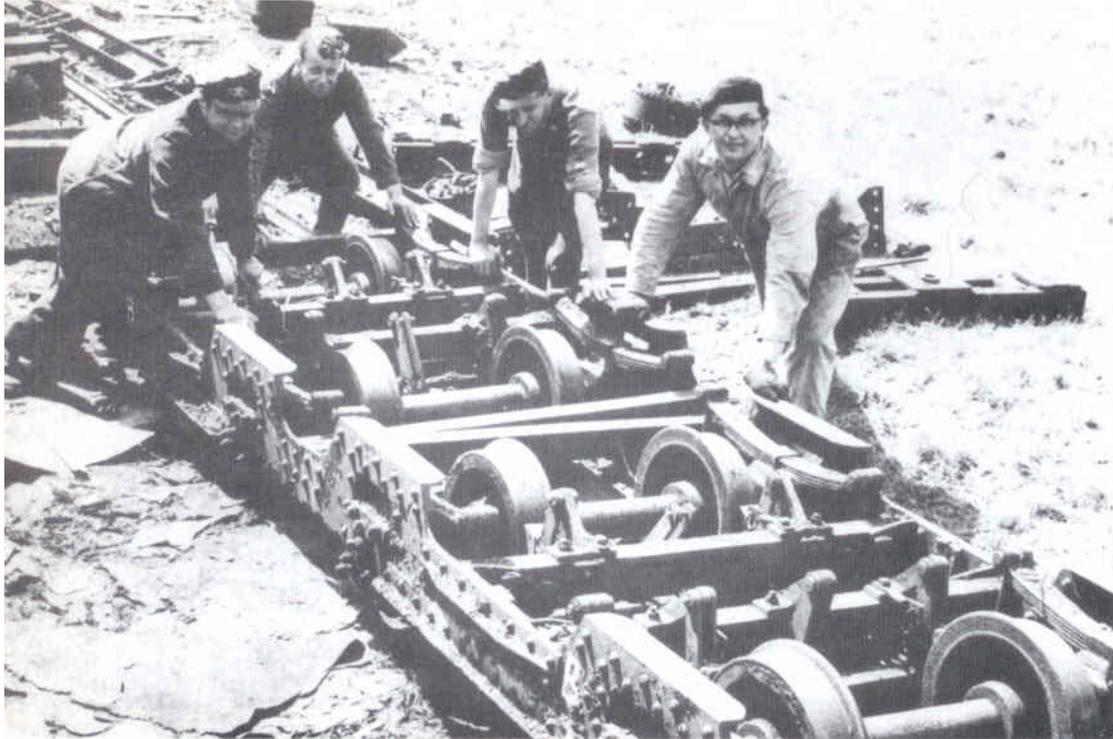
The Festiniog Railway Society removing the Bogies of Coach 15 on 25 April 1959<sup>2</sup>

Leigh: Initially the Bogies were fitted with Roller Bearings but these were not successful and were replaced.<sup>3P82</sup>

Although Leigh states that the FR modified the bogies 'out of recognition', this might not be true. In 1990, the author saw the above two bogies in the carriage shed at Boston Lodge looking quite dirty and much the same as pictured above, did the FR ever use them and are they still there?

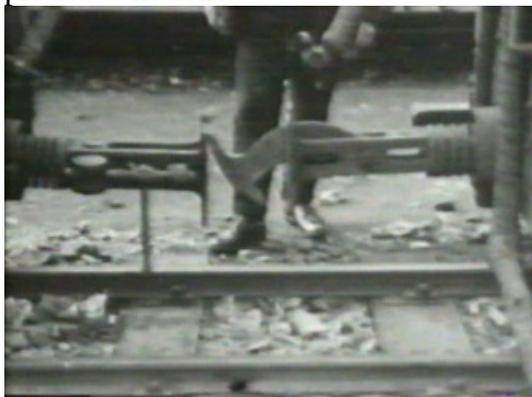
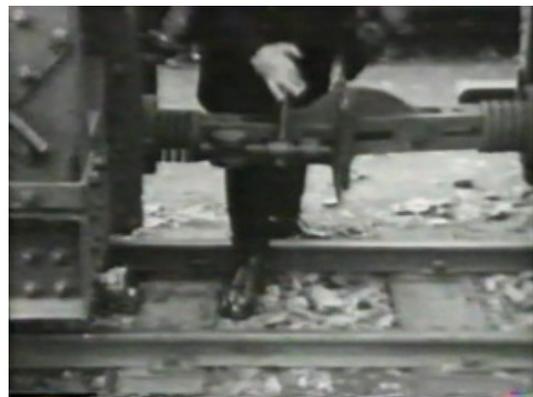
Snapshot images from The Lynton & Barnstaple Railway Video.<sup>IV</sup>

Couplings were of the Norwegian 'Chopper' Type. The 'hook' part being on the front of the Locomotive. Also, there were additional hooks either side of the centre coupling, but these must have been removed at an early date as the centre coupling proved sufficient.

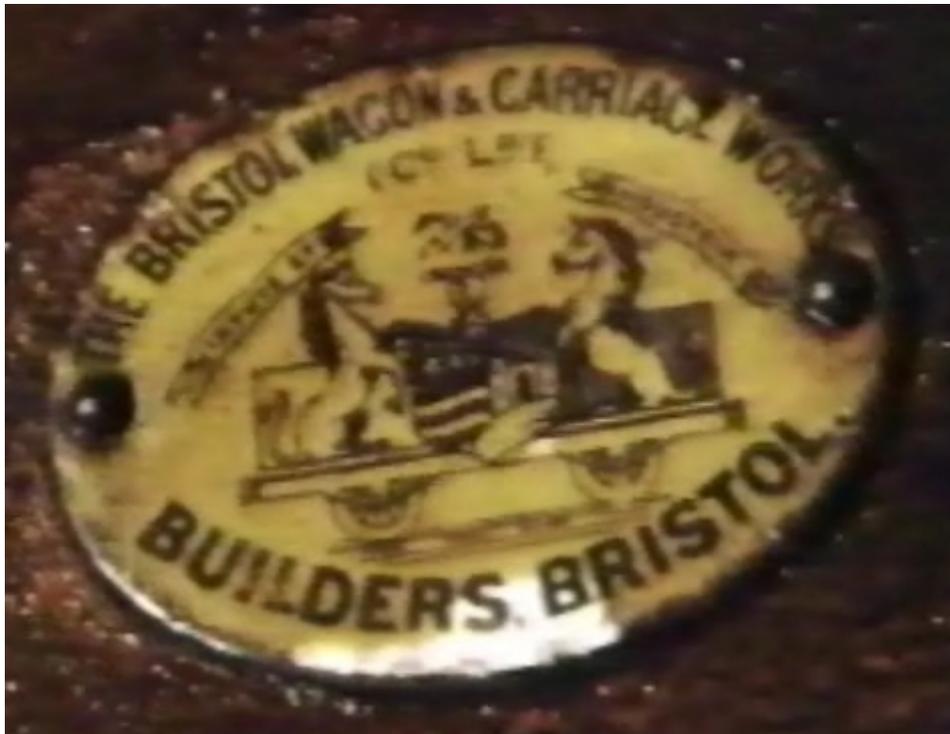
The Bristol Wagon & Carriage Works Builders Plaque (Coach 2 – York Museum)<sup>2v</sup>

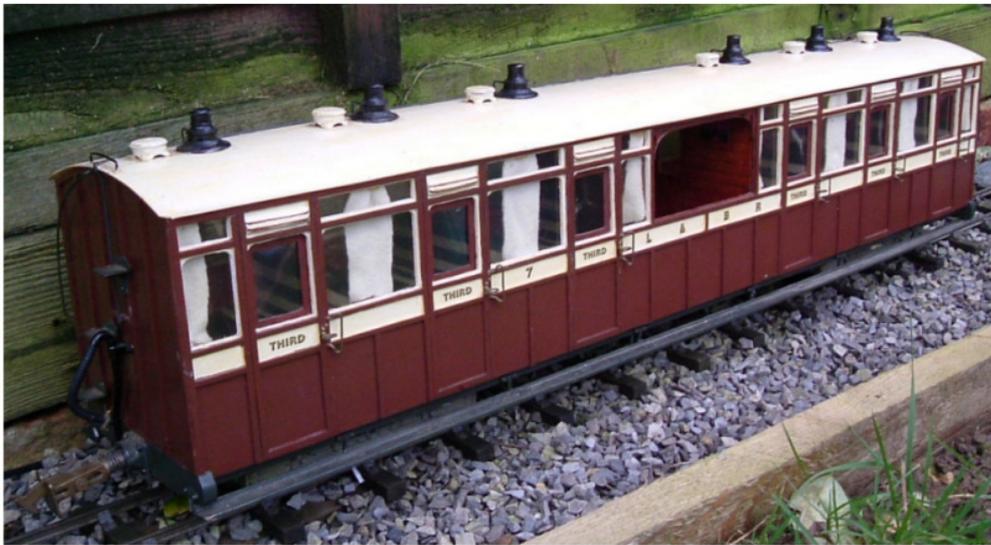
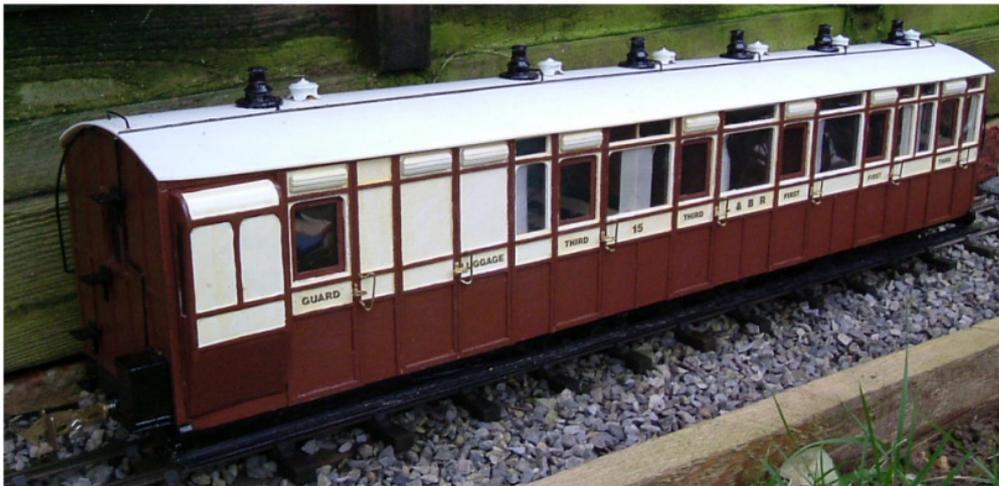
The Authors 16mm (Tenmille) Coach 7 and 15.

Note: the Couplings and vacuum pipes are DJB Engineering, lost wax brass. These couplings are excellent replicas of the original L&B Couplings, also the vacuum pipes can actually be connected together !
